Forest Research Technical Report

TR-034 Geomorphology March 2006

Coastal fan destabilization and forest management

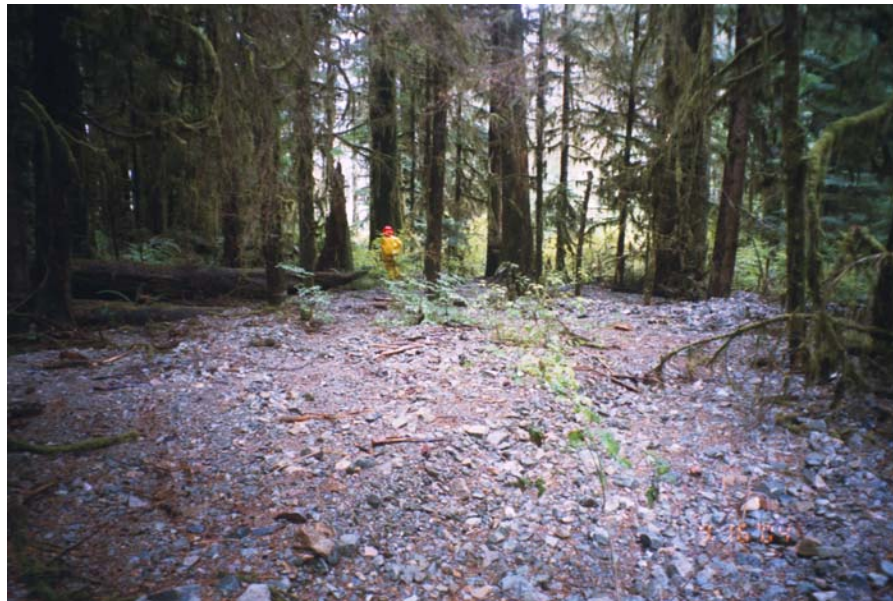
Cover photo: Alluvial fan in a Vancouver Island forest, with an 8m-wide channel ending in a 15m-wide splay of cobbles and fine sediment.

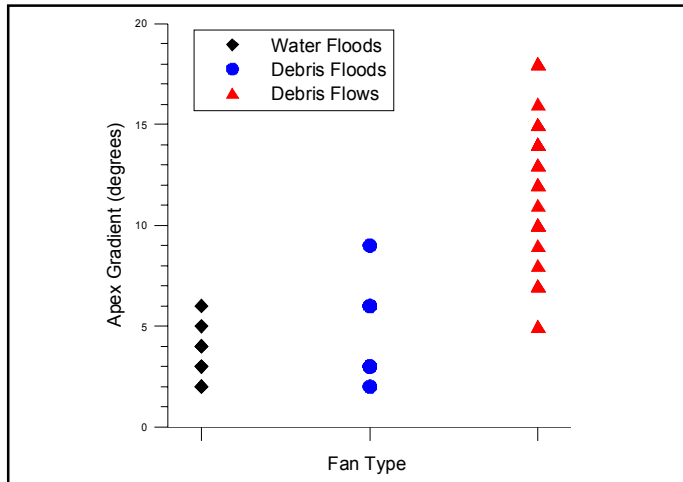
Figure 6. Old process fan type compared with apex gradient.

gradients than either debris flood or water flood fans. Seven debris flow fans had apex gradients of $\leq 8^\circ$. The “old” process classification on five of these fans was noted as “uncertain” due to limited evidence. The debris flood fan with an apex gradient of 9° was difficult to classify because sediment deposits appeared borderline between debris flood and debris flow.

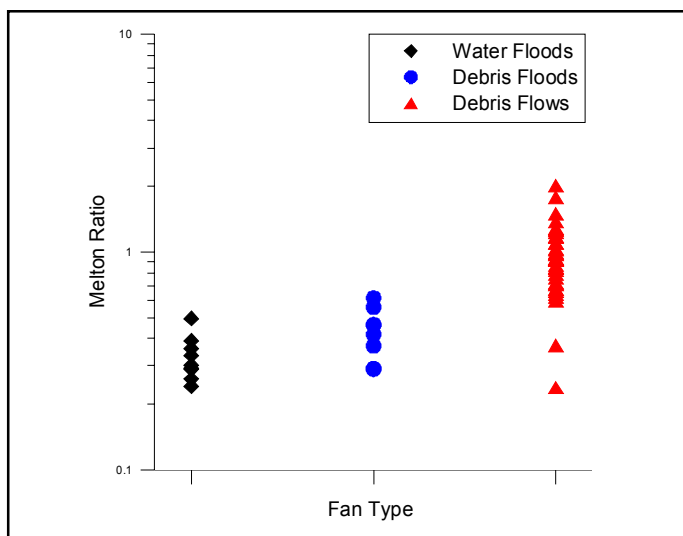
Figure 8. Old process fan type compared with Melton ratio.

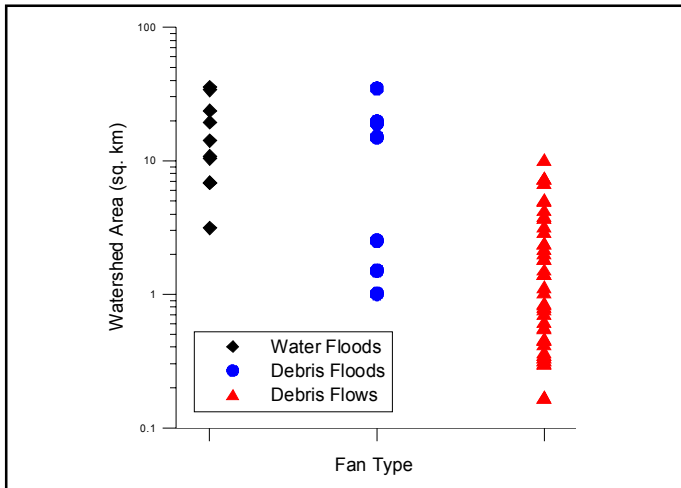
Figure 9. Old process fan type compared with watershed area.

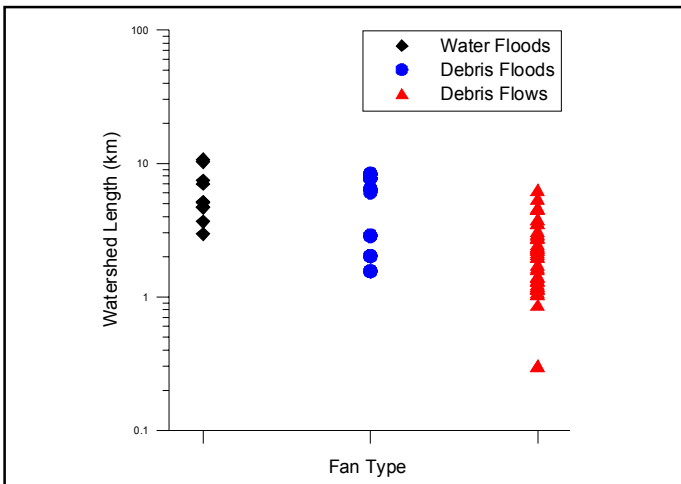
Figure 10. Old process fan type compared with watershed length.

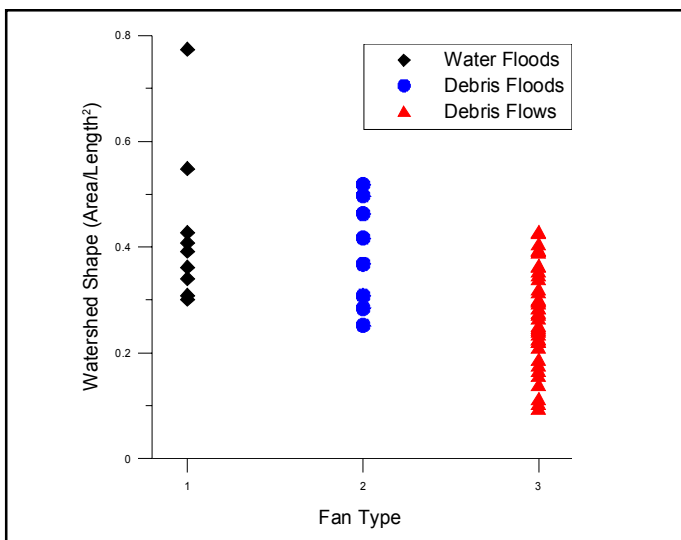
Figure 11. Old process fan type compared with watershed shape.

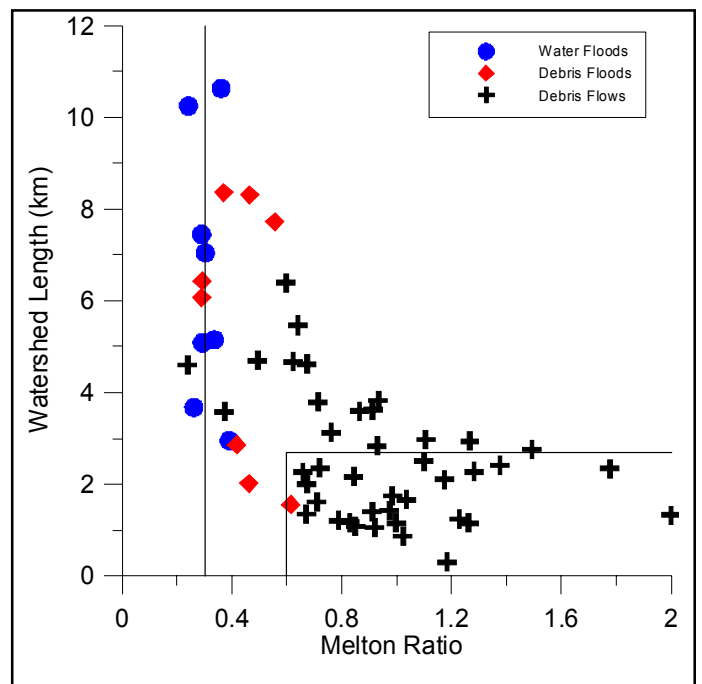
Figure 12. Differentiating fan process using the Melton ratio and watershed length (as proposed by Wilford et al., 2004).

Wilford et al. (2004) found that a combination of watershed length and Melton ratio provided the best predictive ability for fan process, with debris flow fans having a Melton ratio of >0.6 and a watershed length of <2.7 km, and water flood fans having a Melton ratio <0.3 (Table 1 contains the class criteria from Wilford et al.). Figure 12 shows the data for this study plotted using the combination of Melton ratio and watershed length, and the class boundaries determined by Wilford et al. The plot shows that coastal BC fans are similarly classified by Melton ratio, with almost all debris flow fans having a Melton ratio >0.6 , debris flood fans generally having a Melton ratio

between 0.3 and 0.6, and water flood fans generally having a Melton ratio of <0.3.

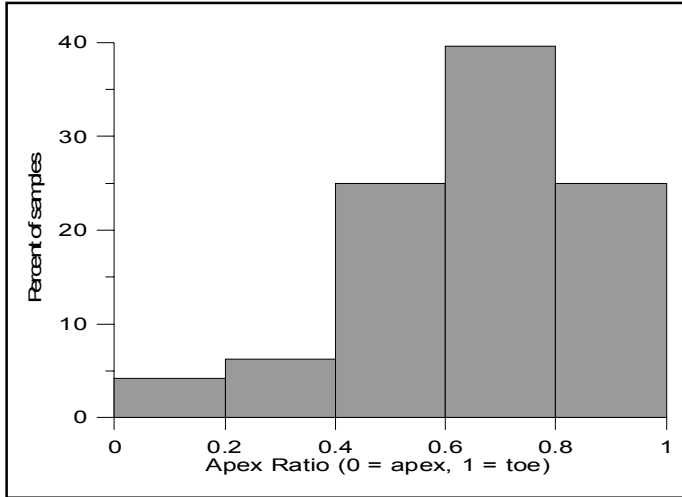
Figure 15. Splay deposits from the apex.

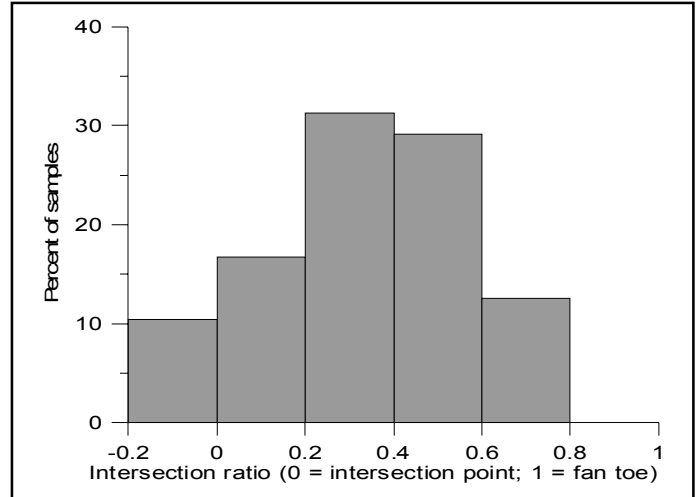
Figure 16. Debris flow deposits from the intersection point.

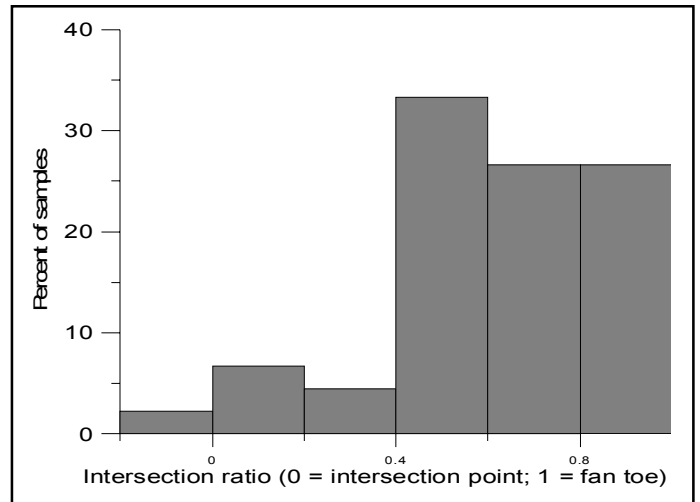
Figure 18. Splay locations from the intersection point.

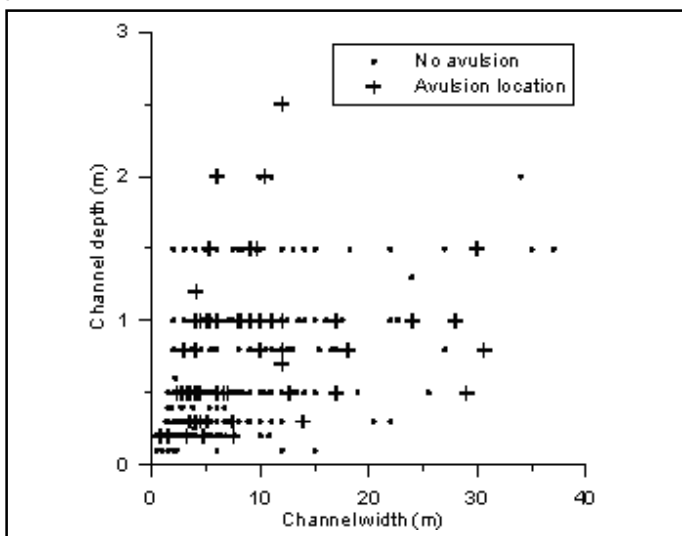
Figure 19. Channel width, channel depth, and the presence or absence of avulsion.

non-avulsion locations compared to channel width and channel incision. Neither channel depth or channel incision appears to have a strong effect on the location of avulsions, with the exception of an upper limit of channel incision. The maximum depth of channel incision at which an avulsion occurred was three metres. Only five avulsions, of a total of 114 observed, occurred when channel incision was greater than 2 m, and four of these avulsions occurred on fans with recent debris flows.

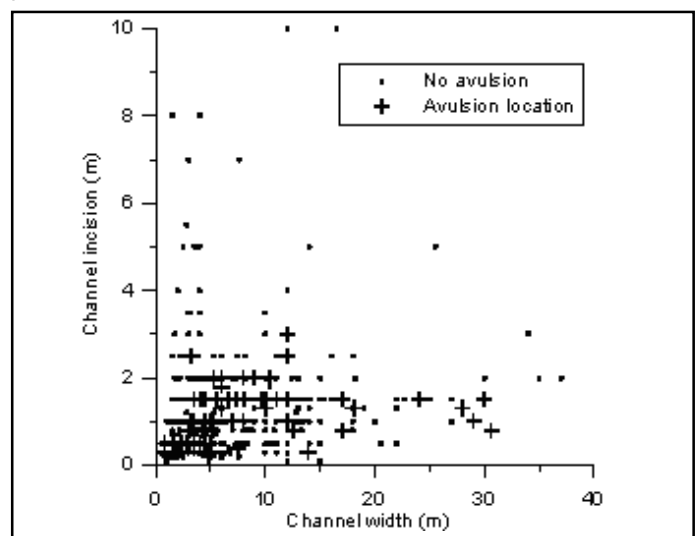
Figure 20. Channel width, channel incision, and the presence or absence of avulsion.

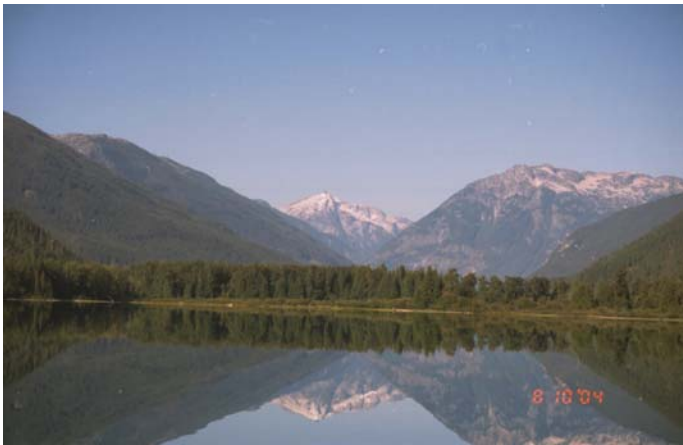
Figure 21. Looking upstream in the Nahatlatch Valley, a typical U-shaped glacial trough with steep sides and flat valley bottom (fans are located where side drainages enter the main valley).

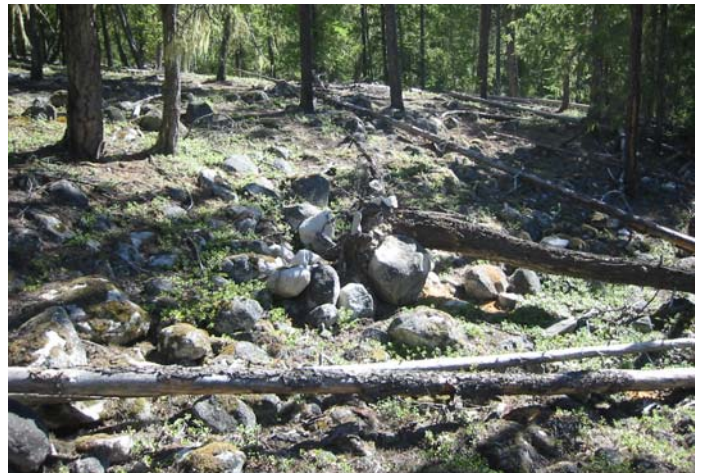
Figure 22. A paraglacial fan surface in the Nahatlatch Valley (this surface is 3-20 m above the contemporary channel).

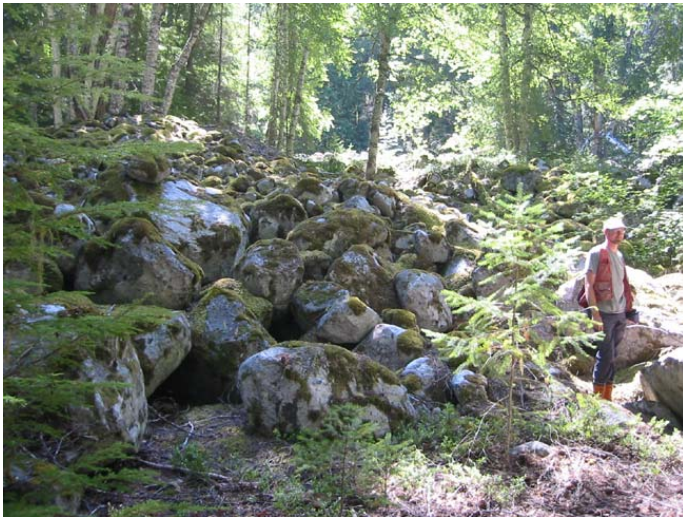
Figure 23. Coarse debris flow lobe deposits (this deposit is at least 50 years old).

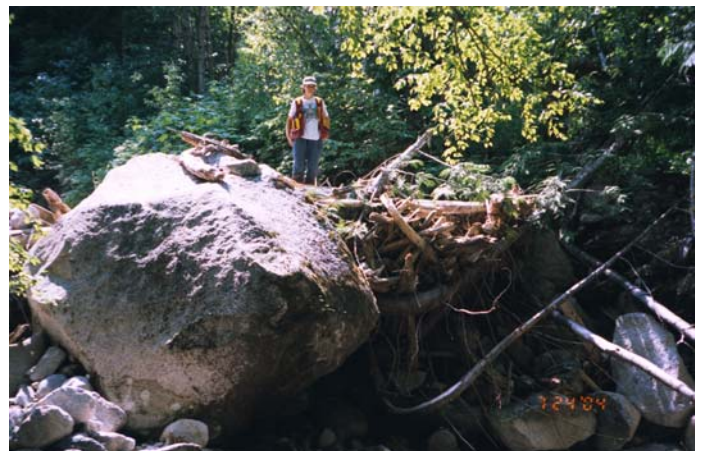
Figure 24. Large debris flow boulder in the centre of an active channel.

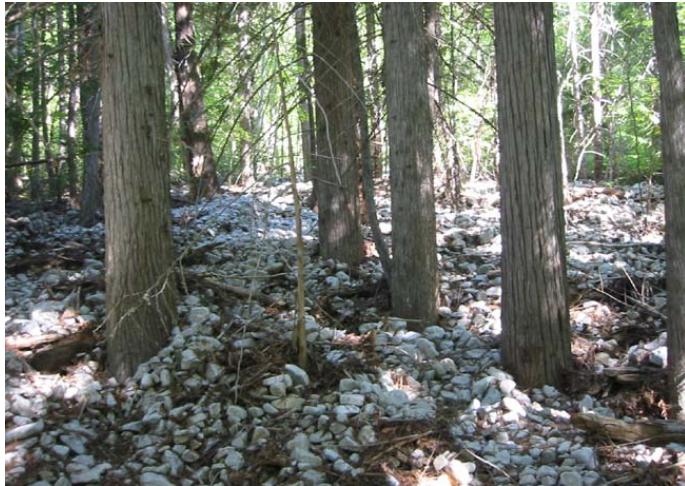
Figure 25. Mid to lower portion of a fan with recent debris flood deposits in a broad splay among trees; a debris flow deposited on the upper portion of the fan about 50 years ago.

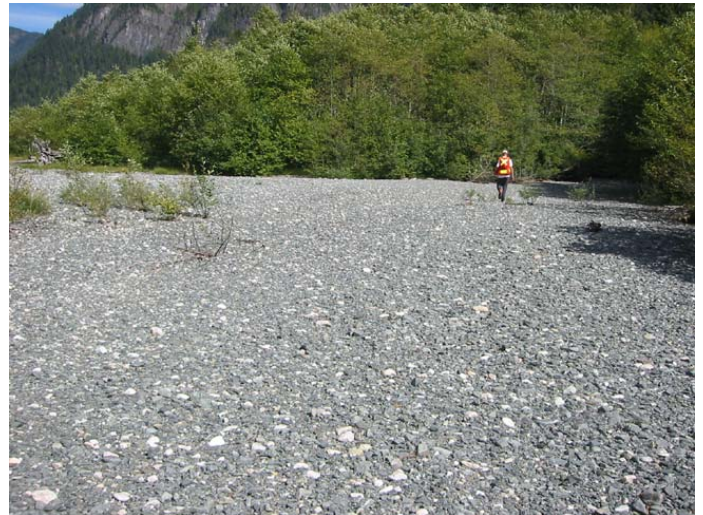
Figure 26. Broad water flood deposits on the lower portion of a fan.

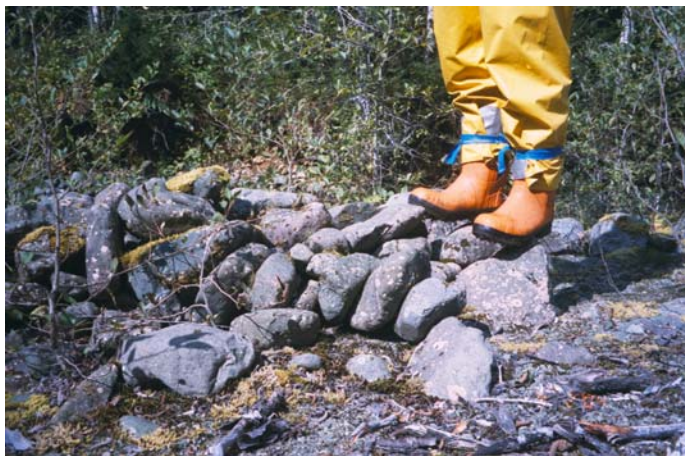
Figure 27. Imbrication of cobbles – an indication of water floods.

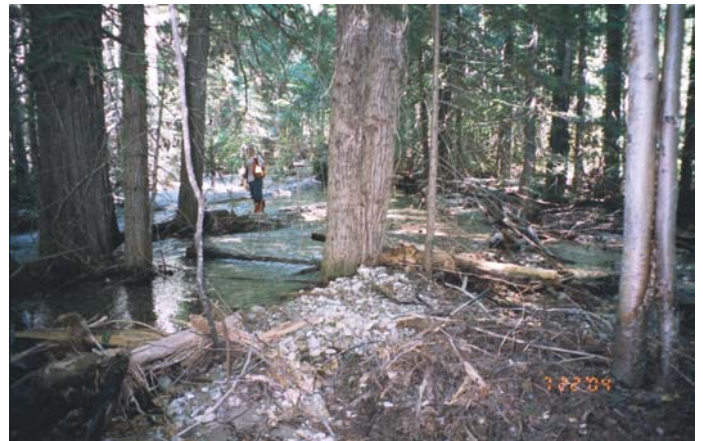
Figure 28. Lower portion a fan with braiding channels and splays that strongly interact with the forest – storing sediments and likely limiting the extent of new channels.

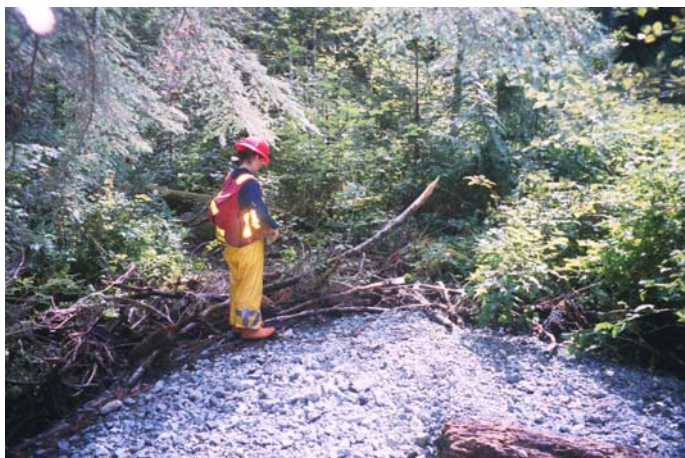
Figure 29. A 6m-wide channel that ends abruptly in a splay. Sediment is composed of cobbles and finer sediment. Beyond this point no channel is evident, although some sand and silt deposits are present.

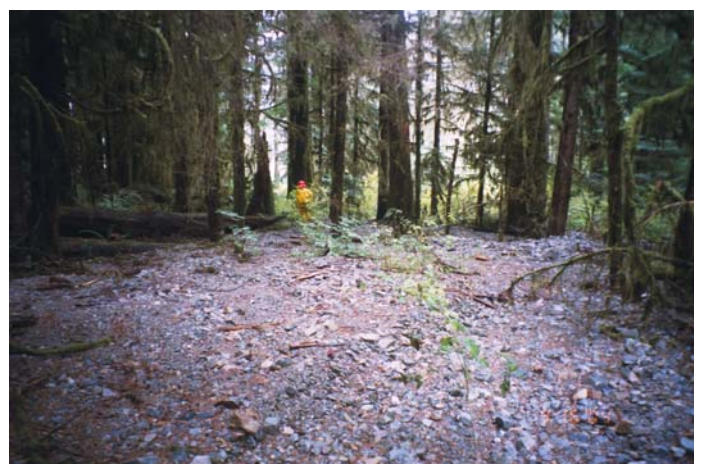
Figure 30. An 8m-wide channel that ends in a 15m-wide splay of cobbles and finer sediment. No defined channel is present past this point and the fan surface is completely vegetated.

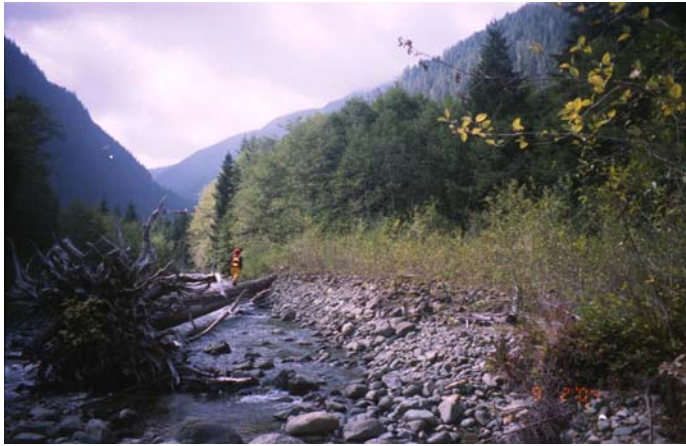
Figure 31. Two ages of red alder cohorts are present along this channel (the 1-2 m high alders in the right-center of the photograph date from about 1994, and the mature alders in the background date from about 1920).

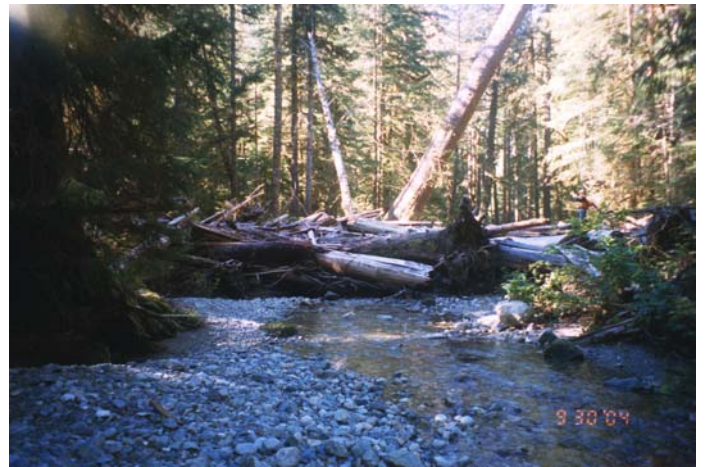
Figure 32. Looking downstream at a large 3m-high woody debris jam. An active avulsion is located on the left of the photo, and dispersed flow occurs around the right side. Note the person located to the right of the jam for scale.

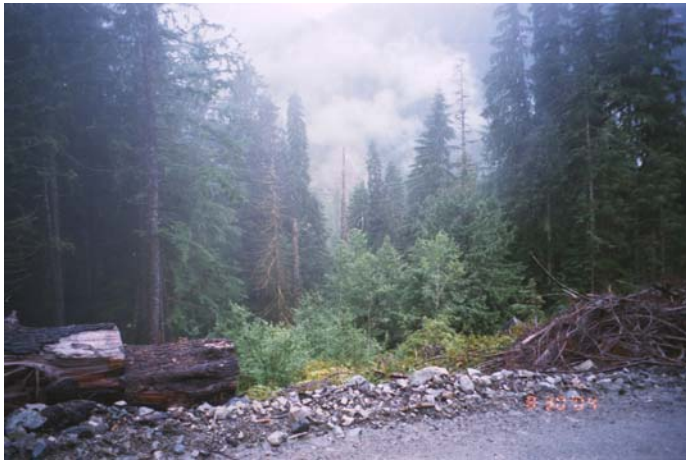
Figure 33. A gap in mature timber caused by a recent debris flow; two cohorts of red alder trees at centre date from about 1986 and 1994.

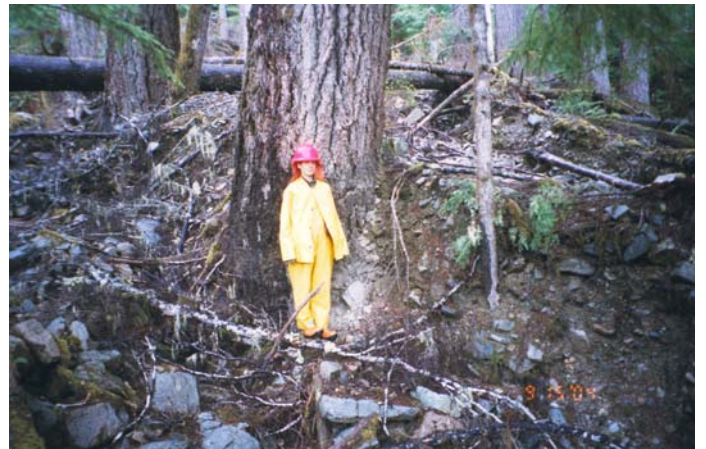
Figure 34. Large tree showing >1 m of deposited sediment and then later excavation on one side.

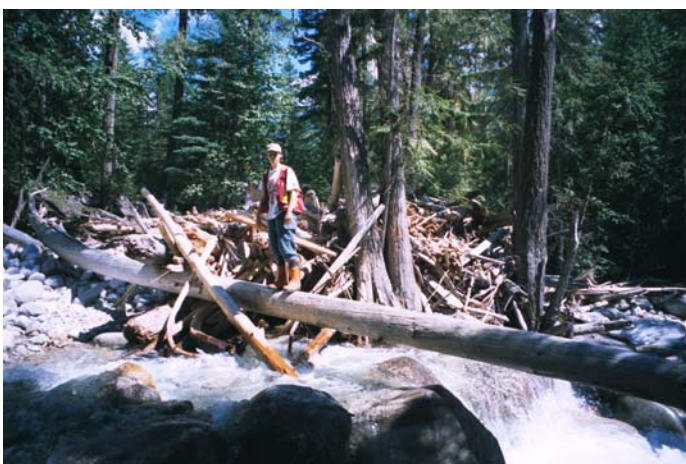
Figure 35. The downside face of a woody debris jam at the apex of a fan.

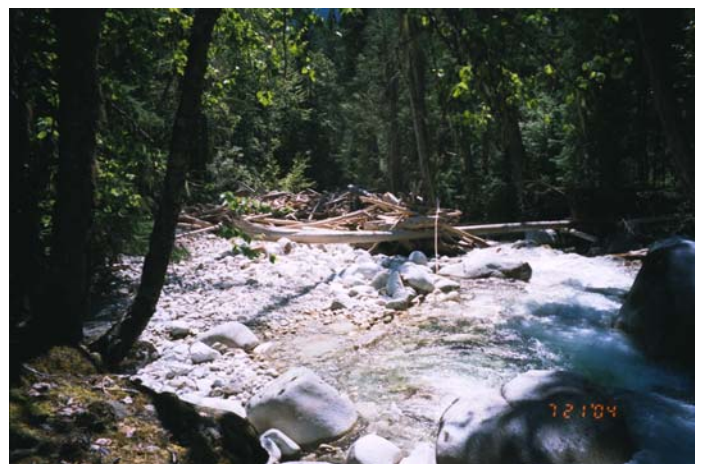
Figure 36. The same jam as in photo at left, but from above, looking downstream; the majority of flow is to the right, but the jam creates a partial avulsion to the left during high flows.

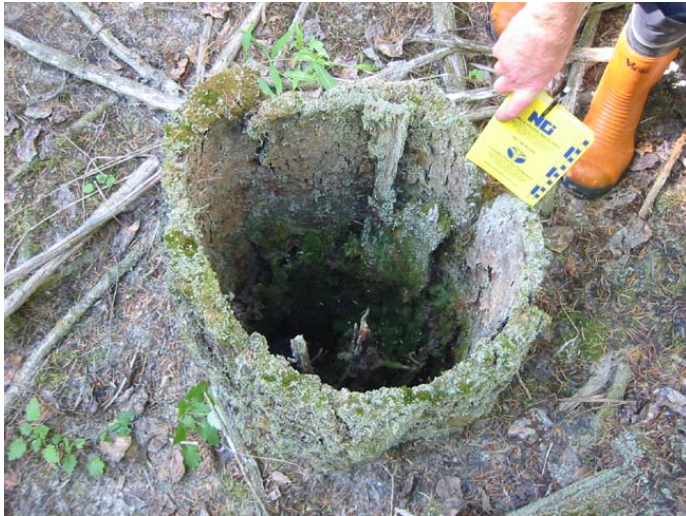
Figure 37. A buried tree trunk indicating deposition of sediment around the tree; the tree later died and rotted, leaving a 1.2m-deep “tree hole”.

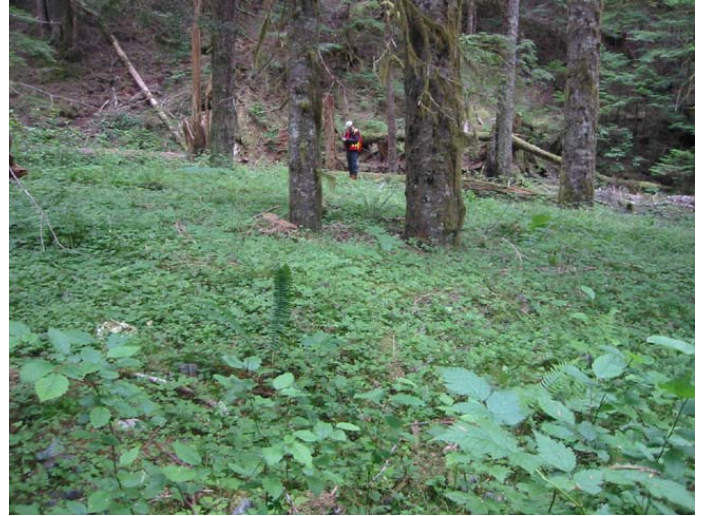
Figure 38. Buried trees on recent broad splay deposits (note the lack of butt flare on the trees).

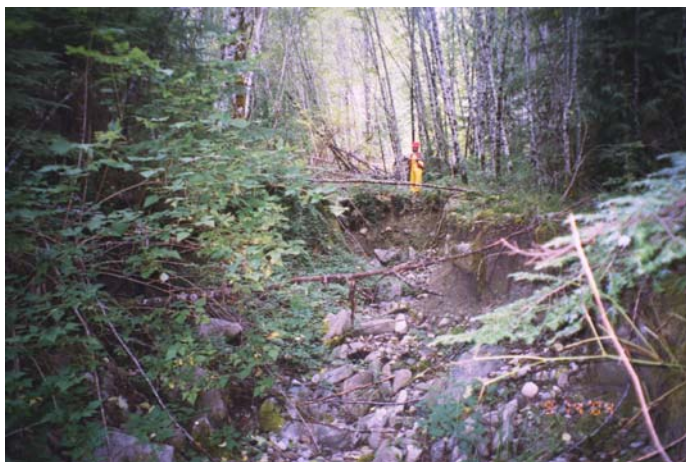
Figure 39. Deep knickpoint erosion along a climbing road that was caused by an avulsion that followed the road alignment.

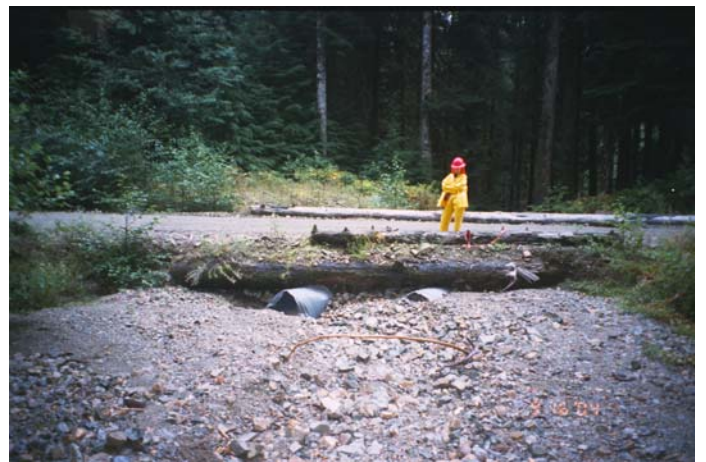
Figure 40. Road crossing of channel with naturally high sediment load (a wider box culvert would allow for better passage of sediment).
